CONFIRMING SYSTEM CHARGE LEVEL AND ADDITIONAL DIAGNOSTIC TIPS FOR TESTING TXV SYSTEMS

Evaporator Superheat Cannot be Used to Determine TXV System Charge Level

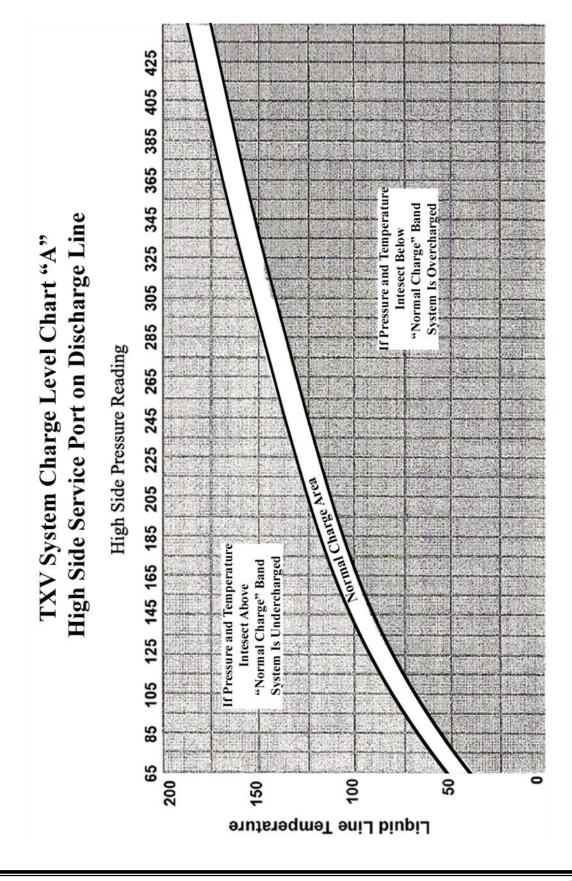
Now refer to the "TXV System Charge Level Chart "A" or "B" pages 3 or 4 (see note below) and find the point where high side pressure and liquid line temperature intersect on the chart. If they intersect in the "Normal" band, the system is close to correct system charge. If they intersect above the "Normal" band, the system is undercharged. If they intersect below the band, then the system is overcharged.

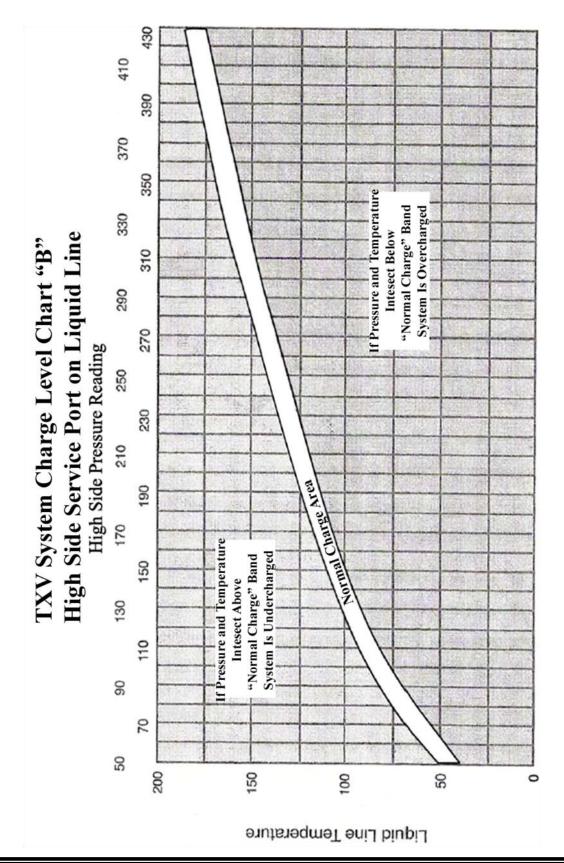
Note: Use chart "A" if the high side service port is located on the compressor or discharge port or line; use chart "B" if the high side service port is on the liquid line.
