## TECH TIP

# COMPRESSOR CLUTCH COIL & BEARING FAILURE DIAGNOSIS

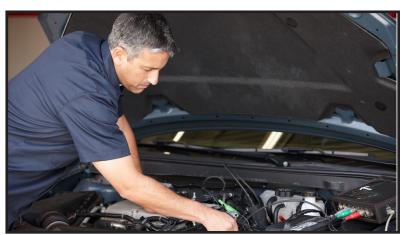
- Start the engine and place the air conditioning system in the max position.
- Using a DVOM back-probe the negative side of the clutch coil connector with the positive probe and place the negative lead at the battery negative post.
- The DVOM should show 0.2 volts or less. Readings higher than 0.2 volts indicate excessive resistance in the circuit. The
  cause for the resistance will need to be found and corrected.
